HISTORIC LANDMARK COMMISSION
APPLICATION FOR A CERTIFICATE OF APPROPRIATENESS
JUNE 28, 2021
C14H-2010-0009; HR-2021-041008
VOSS HOUSE
1501 NORTHWOOD ROAD

Construct a rear and second-level addition.

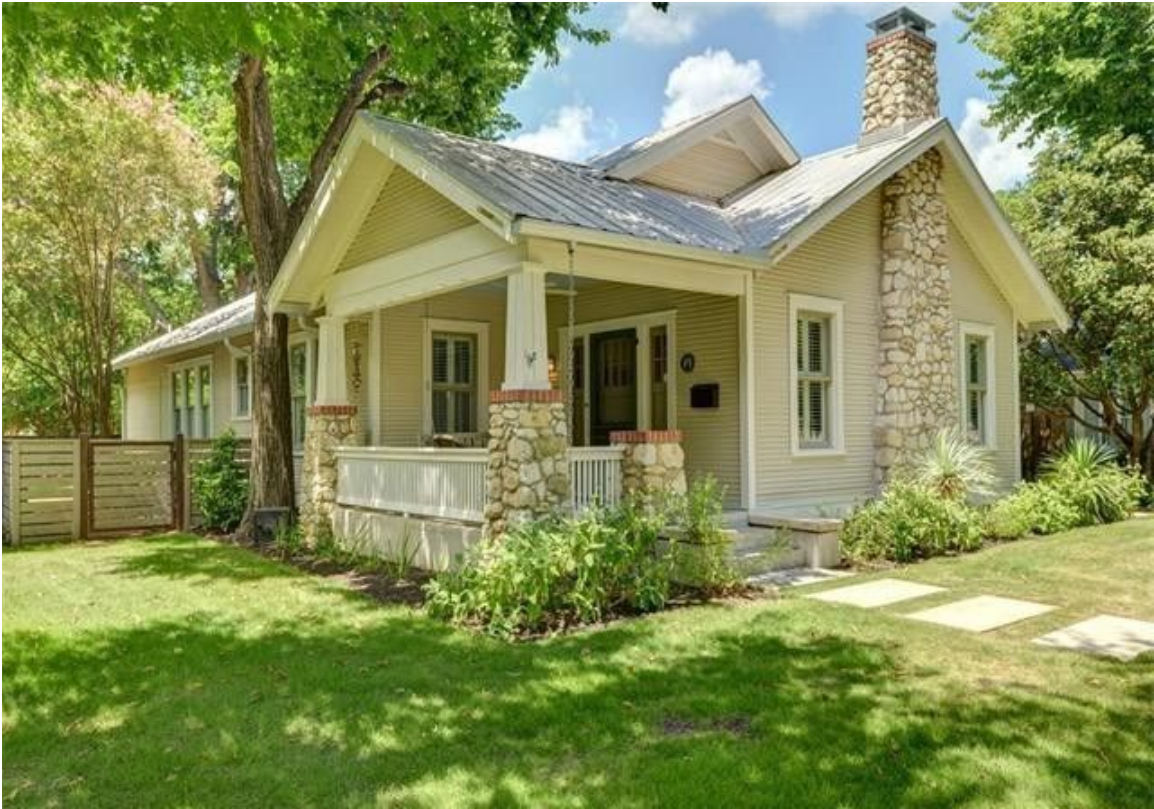
*North and east elevations, view from corner of Northwood Rd. and Harris Blvd.
Photograph provided by applicant.*

The Voss House faces Northwood Road; however, the following description from the landmark nomination considers the Harris Blvd. side as the primary elevation. The house is a one-story, rectangular-plan, side-gabled frame bungalow with a partial-width front-gabled independent porch on battered posts and stone piers with a brick cap and a vertical baluster railing. Fenestration consists of 1:1 wood-frame, wood-sash units in single and multiple configurations; the entry is flanked with sidelights. A battered stone chimney pierces the north side gable of the house.

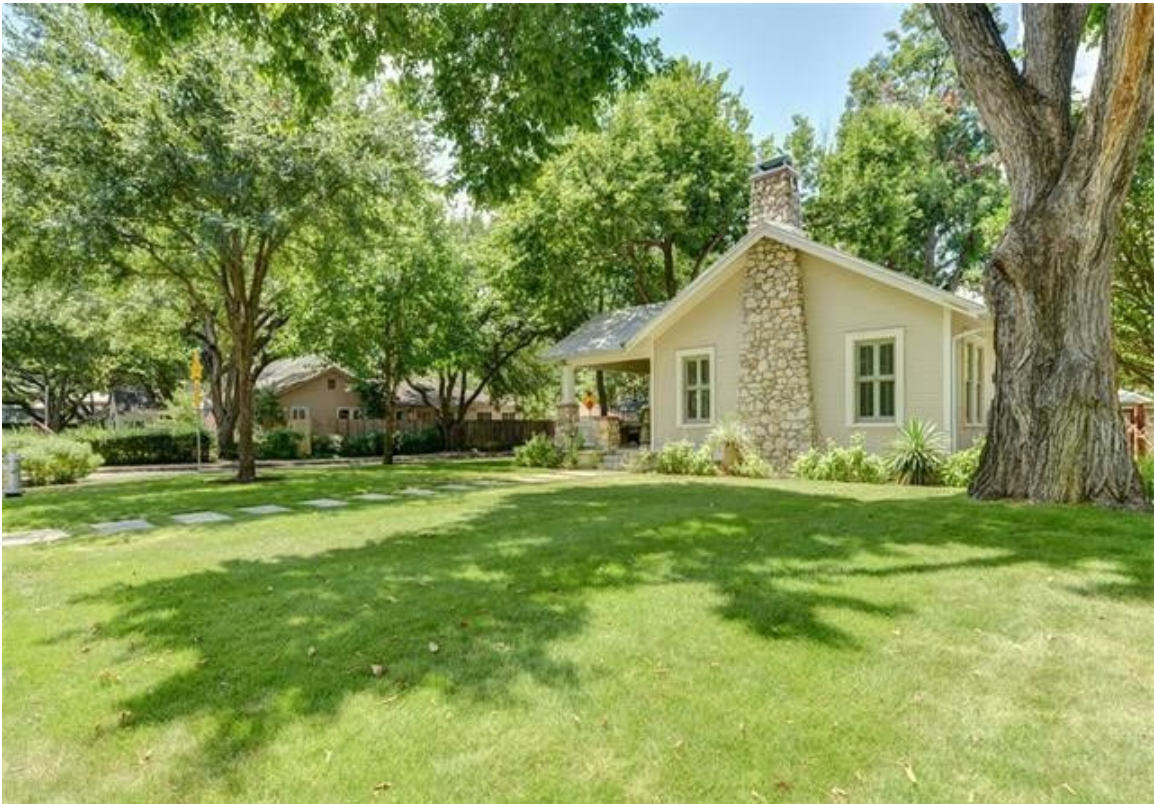
North elevation, view from Northwood Rd. Photograph provided by applicant.

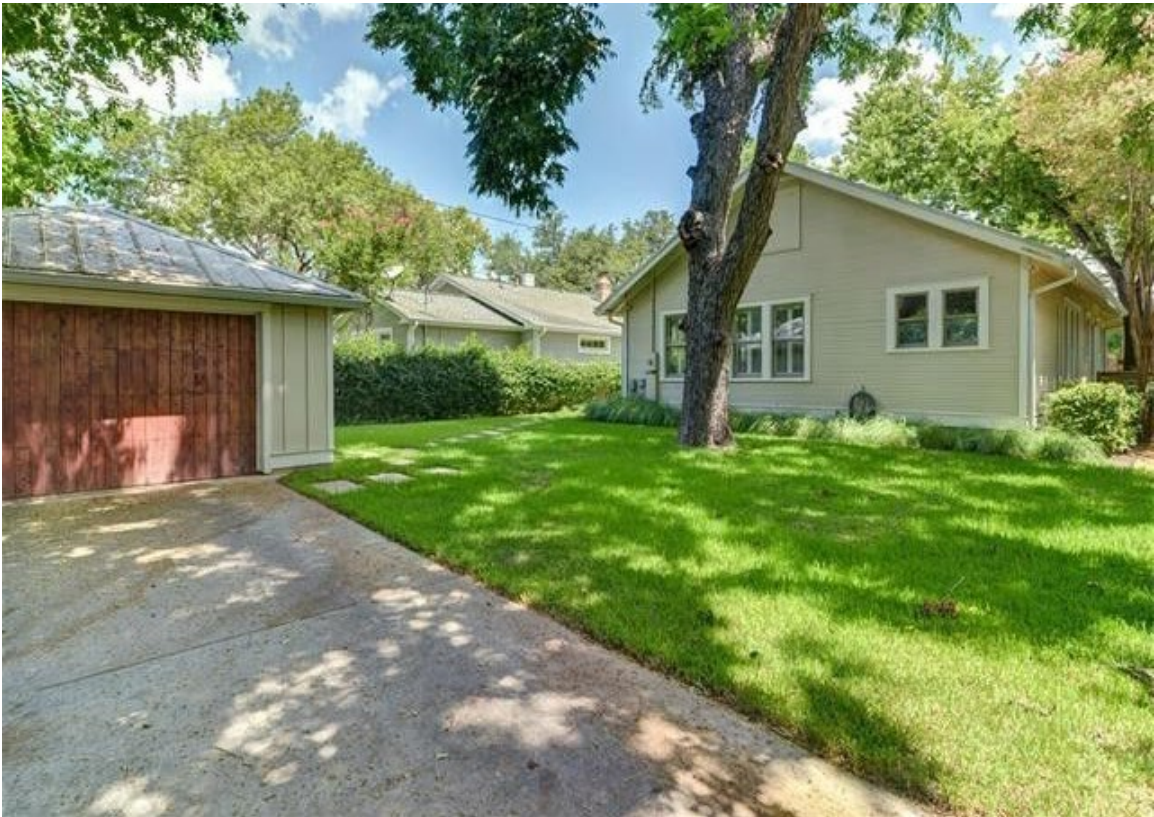
South elevation of house and east elevation of garage. Photograph provided by applicant.

The garage is not mentioned in the landmark nomination. It has a low-pitched pyramidal roof and is clad in board-and-batten siding. The garage is located to the southwest of the house at the rear corner of the property, with a modern overhead garage door facing Harris Blvd. While the 1961 Sanborn Fire Insurance map shows a garage at the same location, it has a different footprint. Building permits show the garage was remodeled in 2000, though the description indicates installation of a concrete slab and interior remodel only.

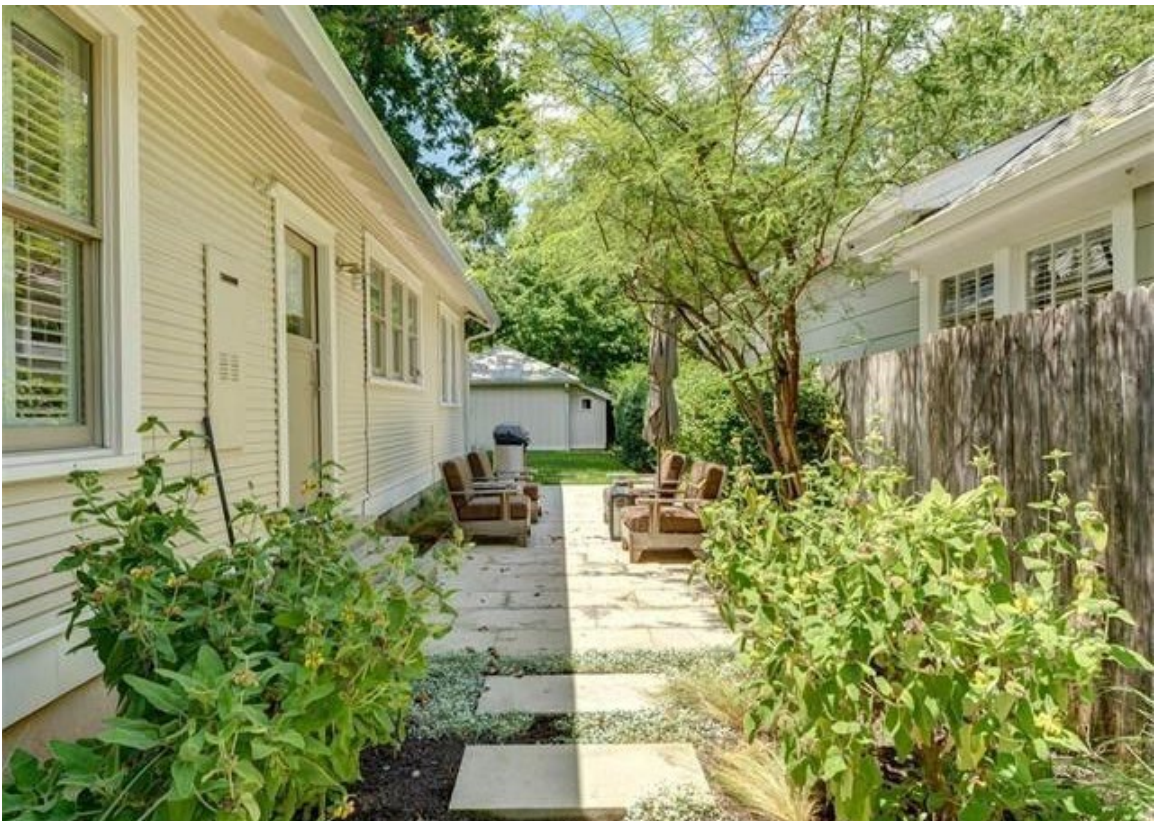
West elevation of house and north elevation of garage. Photograph provided by applicant.

The rear addition minimally engages with the back corner of the house. It will result in removal of paired windows on the west elevation and one out of a grouping of four windows on the south elevation. The second-story addition will involve modification of the roof and roof framing.
